This was a very thorough house inspection. I think the inspector did a great job, however there are a few oversights or incorrect statements:

Here are my comments on each item in the report.

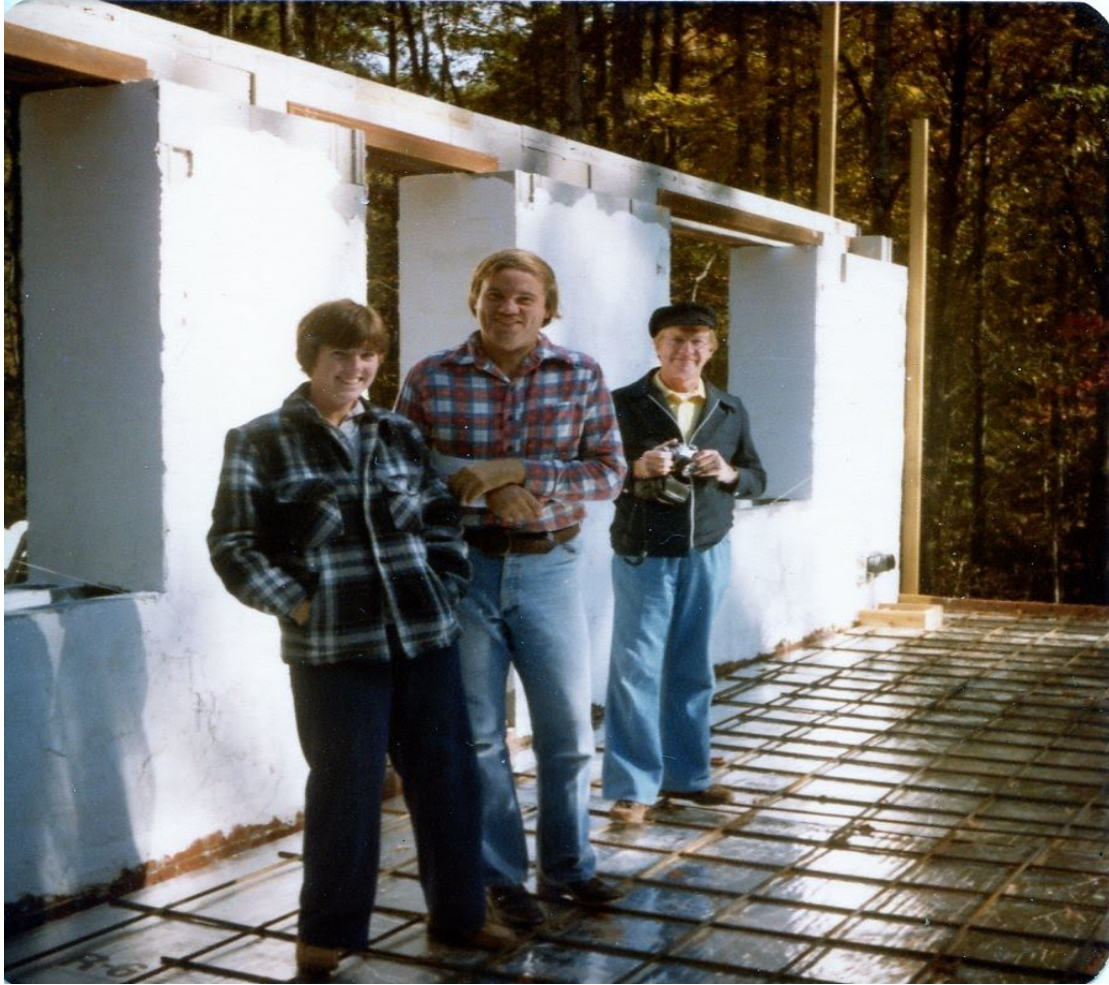
1.2 Floors. The rough sawn boards under the sunroom were the concrete forms for the slab. They were left in place to assist with insulating the slab. The slab is resting on a cinderblock foundation wall on each side, not on these boards. This slab support foundation wall is on a normal footer which was poured as part of the house footers. The slab consists of a grid of tied steel reinforcing rods embedded in concrete. This was inspected by Apex before and after pouring.

The picture shows the rebar grid before concrete was poured.
