Inspection Report

Property Address:
103 Downing Place
Apex NC 27502

Delta Residential, LLC

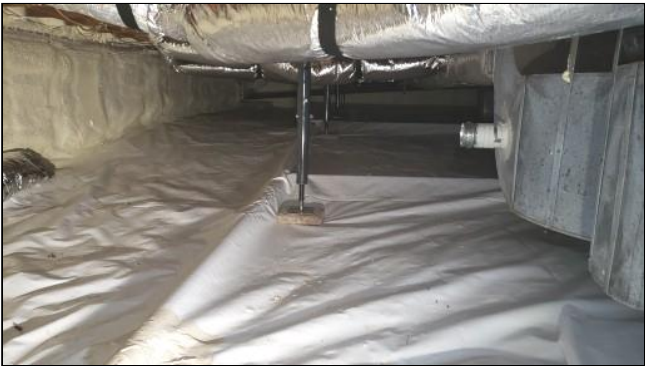
1.0 Item 1(Picture)

(1) The crawlspace has been sealed but I did not locate a conditioned air supply vent from the HVAC heating and cooling system. It is recommended that the seller provide all documentation and warranties concerning the sealed crawlspace. Retain all documents for future reference.

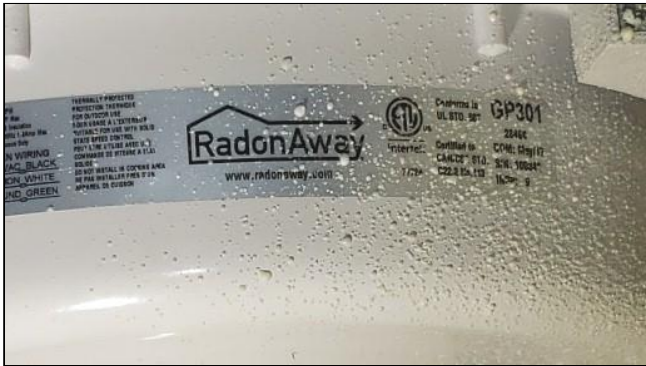
1.0 Item 6(Picture)

(2) A radon mitigation system is installed in the crawlspace. Testing the system is beyond the scope of a professional home inspection. It is recommended that the seller provide all documentation, radon test results(if any), and warranties concerning this system.

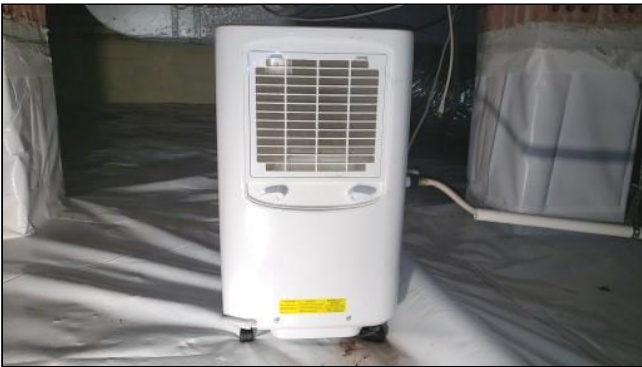
1.0 Item 10(Picture)

(4) A household-type dehumidifier has been installed in the crawlspace. This type of appliance is not typically rated for use in crawlspaces and is a potential safety hazard. A licensed general contractor experienced in crawlspace atmospheres should evaluate further and perform all necessary repairs, if any are required.

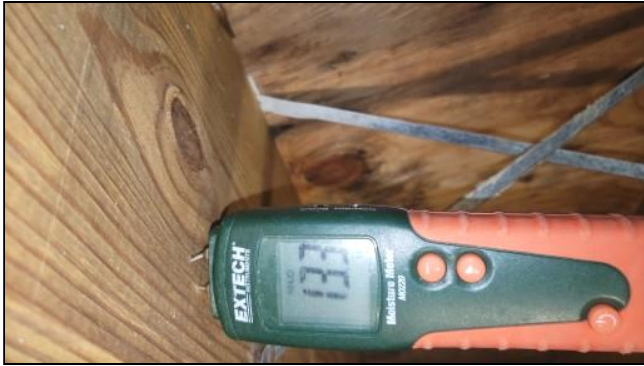
1.0 Item 13(Picture)

(5) Random moisture readings of the wood floor structure components contained in the crawlspace were performed. The highest reading was slightly below 17%. Sustained moisture levels of 18% and higher could create an environment that attracts wood destroying insects and an atmosphere that is conducive to fungal growth. There were no visible signs of damage from high sustained high moisture levels. This comment is for information purposes only.

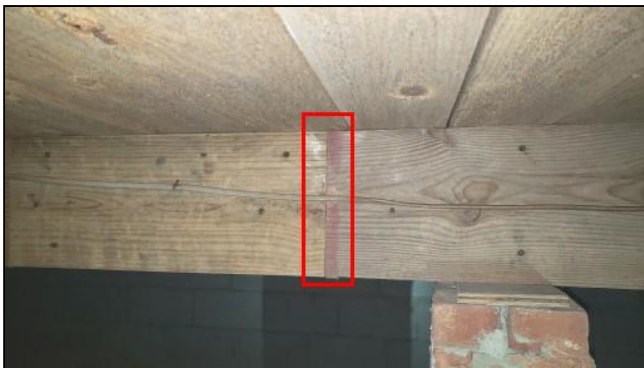
1.2 Item 1(Picture)

(1) Several of the dropped girder plies in the sunroom crawlspace are not supported by masonry piers. Rough-sawn boards appear to be supporting the floor structure. I am unable to determine the composition of the floor structure above the rough-sawn boards however foil covered insulation board was visible in some of the gaps. The floor structure does not appear to be adequately supported and movement could occur if the above conditions are not addressed. A licensed structural engineer should evaluate to determine if any actions are needed. All recommended repairs should be performed by a licensed general contractor.

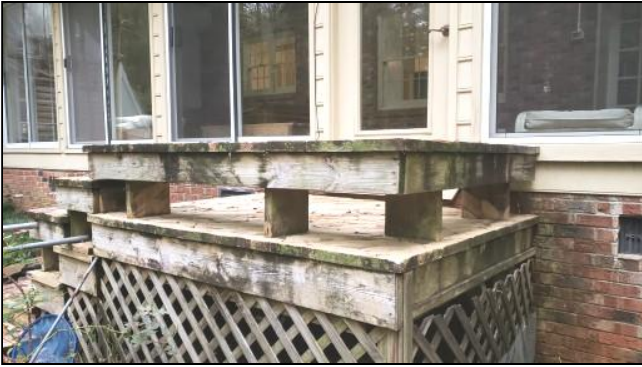
1.2 Item 4(Picture)

(2) The rear step structure appears to be freestanding and it is not laterally braced. I could not confirm that the support posts were bearing on a proper footing. The structure is a potential safety hazard and

should be evaluated by a licensed structural engineer. All recommended repairs should be performed by a licensed general contractor.

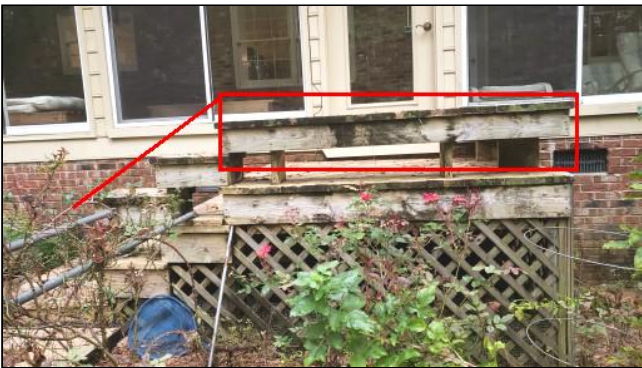
1.2 Item 5(Picture)

(3) Rails are not present on the rear exterior stair structure. Personal injury could occur if this is not addressed. A licensed general contractor should perform this repair.

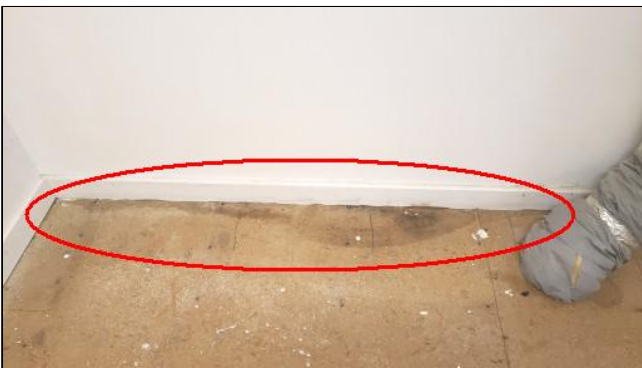
1.2 Item 6(Picture)

(4) Moisture stains are present on the particleboard in the unfinished room of the bonus room adjacent to the greenhouse. Damage could occur to the adjacent wall and floor structures over time if this is an active leak and it is not addressed. A licensed general contractor should evaluate further to determine if any repairs are needed.

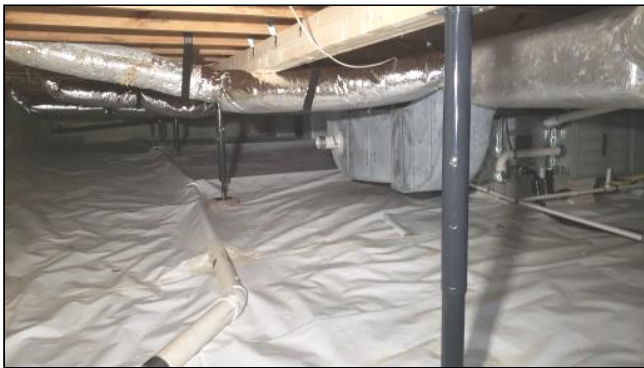
1.2 Item 9(Picture)

(5) A triple 2 x 6 drop girder supported by adjustable metal peers on an insufficient footing are present in the crawlspace. Movement could occur in this support structure if repairs are not performed. A licensed structural engineer should evaluate to determine if any additional actions are needed. All required repairs should be performed by a licensed general contractor.

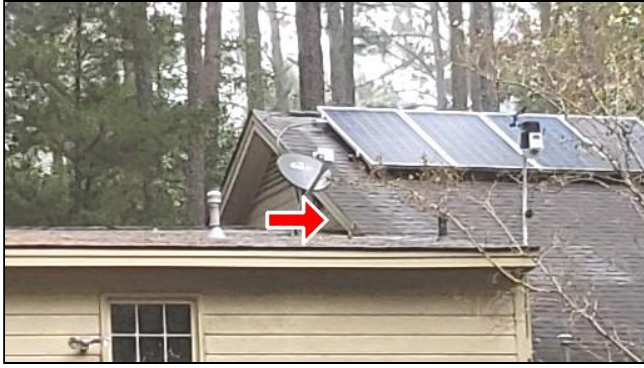
1.4 Item 1(Picture)

A cricket is not visible where the right rear main roof gable soffit system meets the roofing shingles. Moisture could get trapped in this area causing damage if this is not addressed. A licensed general contractor should evaluate further and perform all necessary repairs.

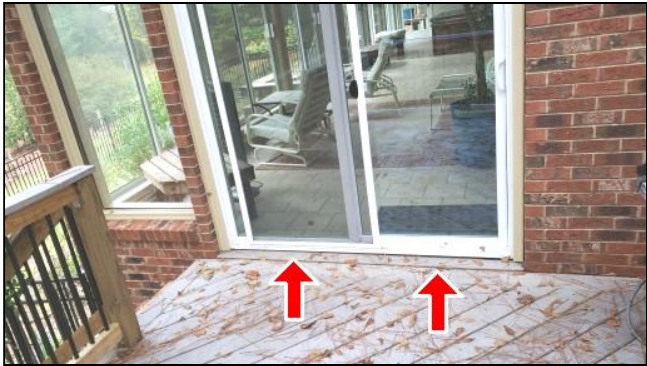
2.1 Item 1(Picture)

(1) The left side sliding glass door sill is not supported or sealed where it meets the deck. Damage could occur to the door and moisture could infiltrate below the door if this is not addressed. A qualified contractor should perform this repair.

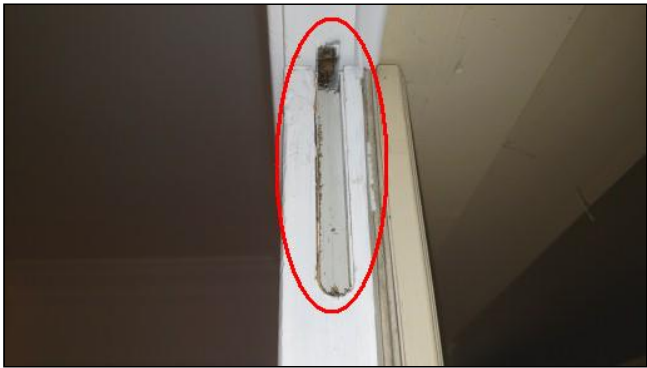
2.1 Item 3(Picture)

(2) The upper slide bolt is not installed on the front entry door. The door cannot be securely locked until this has been addressed. A qualified contractor should perform this repair.

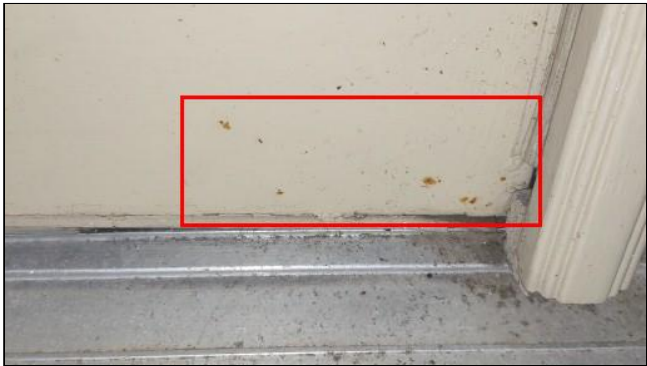
2.1 Item 4(Picture)

(3) Corrosion is present on the front entry door. Additional corrosion could occur if this is not addressed. A qualified contractor should evaluate further and perform all necessary repairs.

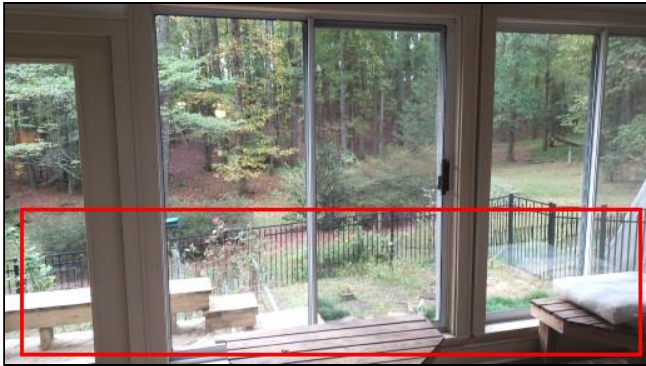
2.1 Item 5(Picture)

(4) The sunroom rear wall sliding glass doors open fully without any type of guardrail. The doors are potential personal injury hazards until they have been addressed. A qualified contractor should evaluate further and perform all necessary repairs.

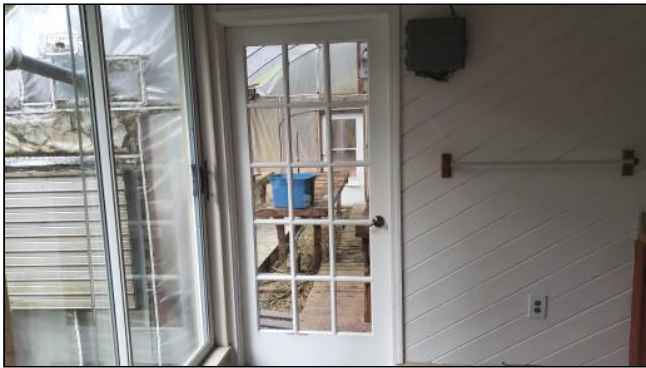
2.1 Item 7(Picture)

(5) The door from the sunroom to the greenhouse is moisture damaged. Additional damage will occur if this is not addressed. A qualified contractor should perform this repair.

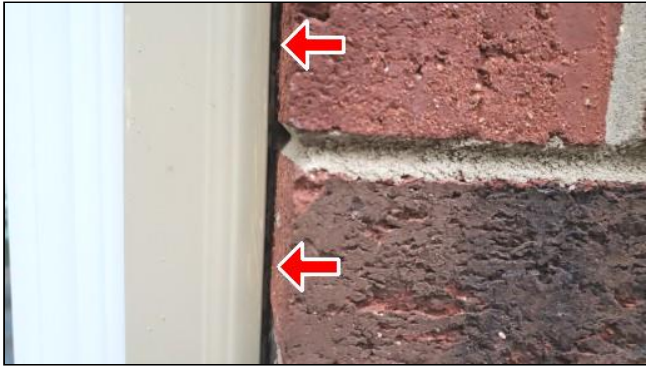
2.3 Item 1(Picture)

(1) Sealant is not present or the sealant is damaged around several window and door openings where they meet the brick veneer. Moisture could infiltrate through these areas causing damage to the adjacent wall and floor structures if they are not addressed. A qualified contractor should perform these repairs.

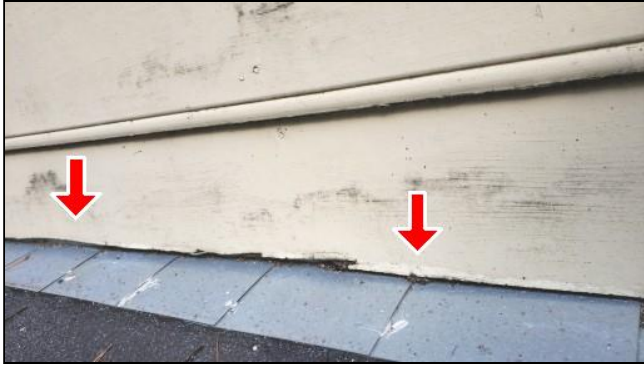
2.3 Item 3(Picture)

(2) The siding is moisture damaged on the rear upper level wall where it meets the shingled roof adjacent to the greenhouse. Additional damage could occur if this is not addressed. A qualified siding contractor should perform this repair.

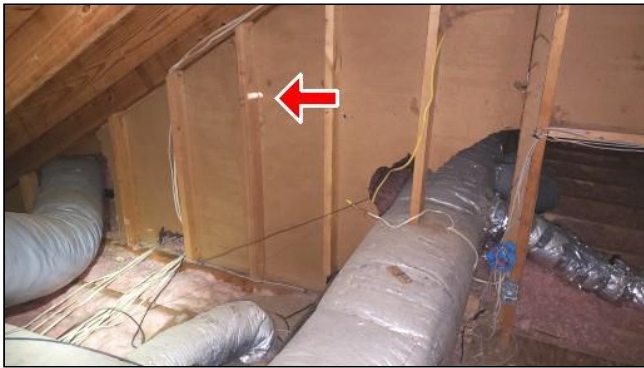
2.3 Item 4(Picture)

(3) A hole is present in the right upper level gable wall. Moisture and animal life could enter the hole causing damage if this is not addressed. A qualified contractor should perform this repair.

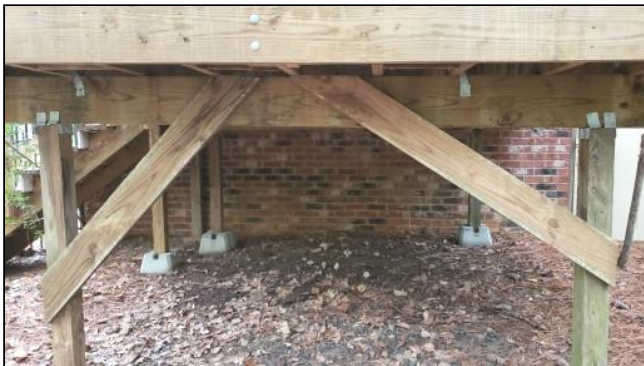
2.6 Item 1(Picture)

(1) Lateral bracing is not completely installed on the left deck support posts. Two lateral braces are installed with nails and no other visible means of attachment. The deck structure could sway or shift potentially leading to structural failure if bracing is not properly installed. A licensed general contractor should evaluate further and perform all necessary repairs.

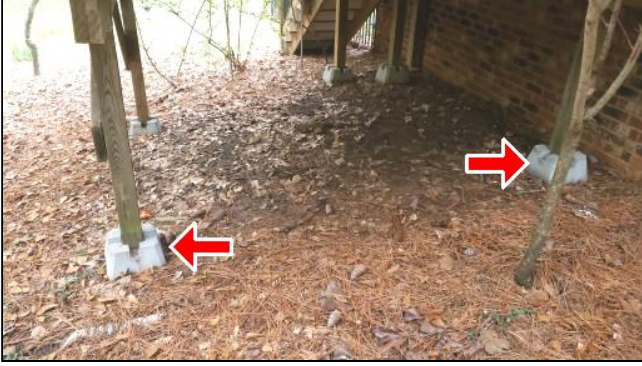
2.6 Item 3(Picture)

(2) The left deck post are bearing on footings that are not stable. Movement could occur in the deck structure if they are not addressed. A licensed general contractor should evaluate further and perform all necessary repairs.

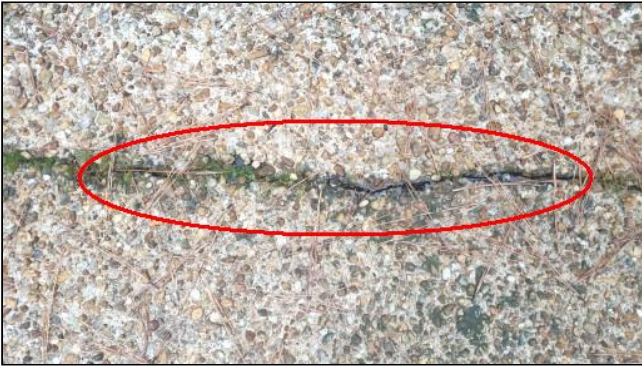
2.8 Item 1(Picture)

(1) Cracks were noted in the front sidewalk. No measurable vertical displacement was noted at the time of inspection. Cracks typically occur due to the process of expansion and contraction caused by changing atmospheric conditions and possible settlement of the soils and/or fill materials below the concrete. Periodic monitoring should be performed on the cracks. Moisture could infiltrate these cracks possibly creating additional damage especially during freezing conditions. A qualified contractor should seal the cracks to prevent moisture infiltration.

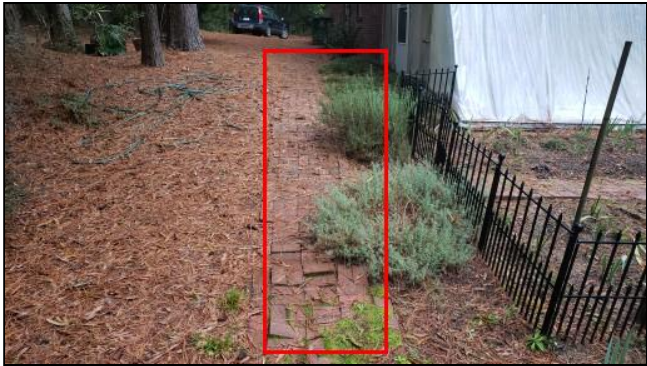
2.8 Item 2(Picture)

(2) Several of the brick pavers in the sidewalk are raised above the adjacent pavers, some pavers are unstable, and low spots are present in the sidewalk. Personal injury could occur if they are not addressed. A qualified paver installation contractor should evaluate further and perform all necessary repairs.

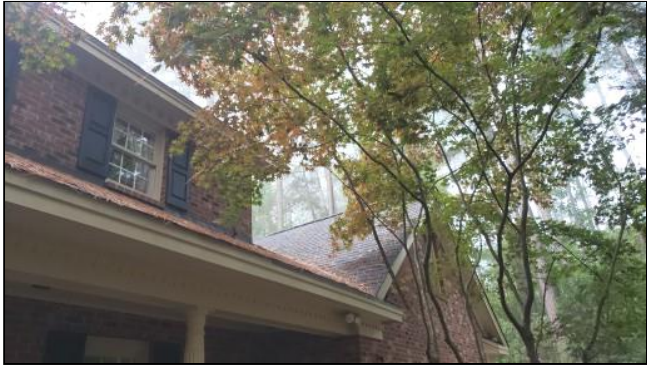
2.8 Item 5(Picture)

(3) Trees are growing over and/or in contact with the front and left sides of the home. Damage to the home's exterior and roofing shingles could occur if these conditions are not addressed. A qualified arborist should evaluate further and perform all necessary repairs.

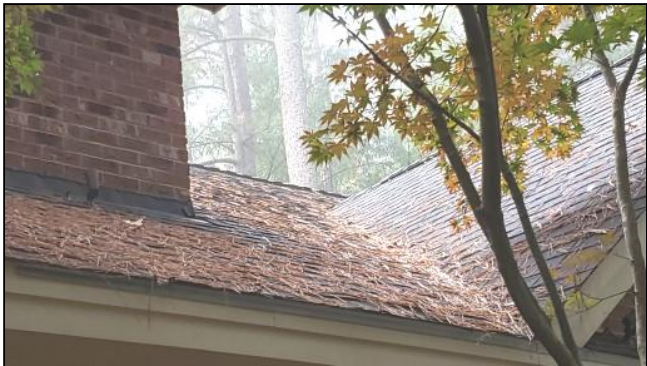
3.0 Item 1(Picture)

- Inspected, Repair or Replace**
(1) Portions of the roof are covered with debris. Debris holds moisture on the shingles that could accelerate aging of the roof covering and create ice dams. A qualified contractor should remove the debris from the roof, evaluate these areas for potential damage, and perform all necessary repairs, if any are needed. No representation is made in this inspection report as to the condition of the areas that were covered in debris.

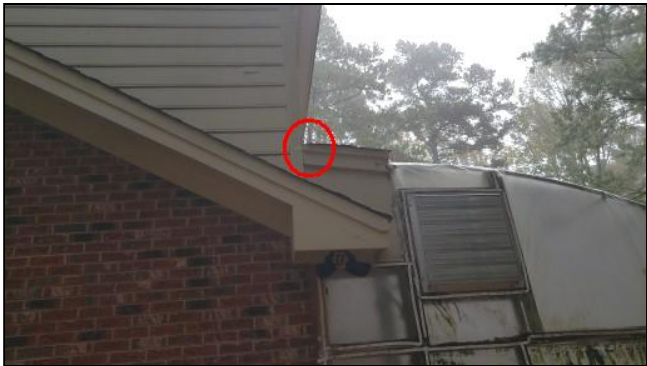
3.0 Item 2(Picture)

(2) Roofing shingles or flashing does not cover the eave trim on the right side of the home where the greenhouse framing meets the rear wall on the second level. Moisture could infiltrate through this area causing damage if it is not addressed. A qualified roofing contractor should evaluate further, examine for concealed damage, and perform all necessary repairs.

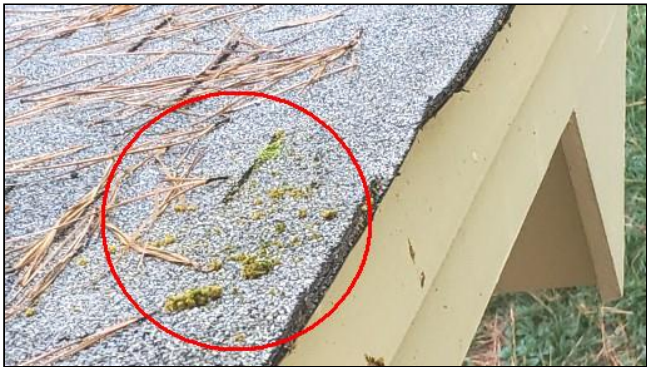
3.0 Item 4(Picture)

(3) Fungal growth is present on the roofing shingles. Fungal growth retains moisture and could accelerate the aging of the shingles if it is not removed. A qualified roofing contractor should evaluate further and perform all necessary repairs.

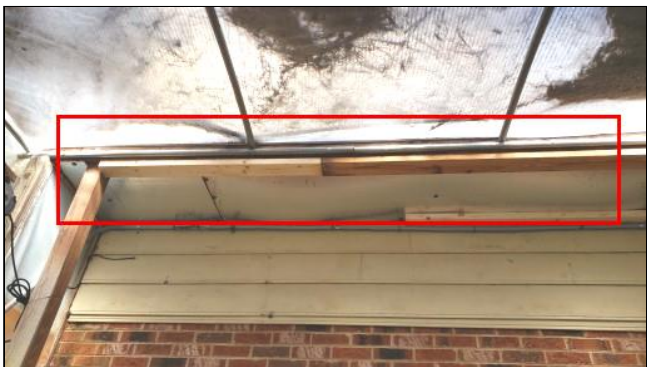
3.0 Item 6(Picture)

(4) The greenhouse roof appears to leak where it attaches to the rear of the home. Damage could occur to the home if this is not addressed. A licensed general contractor should evaluate further and perform all necessary repairs.

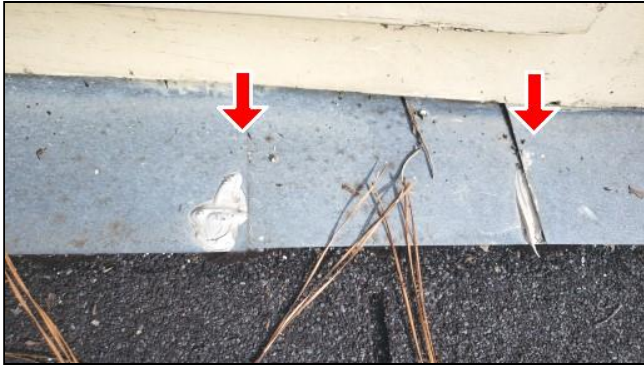
3.1 Item 1(Picture)

(1) Step flashing is present where the shingled roof between the greenhouse and home meets the rear upper level wall. Moisture could infiltrate below the step flashing causing damage to the adjacent building components if this is not addressed. A qualified roofing contractor should evaluate further and perform all necessary repairs.

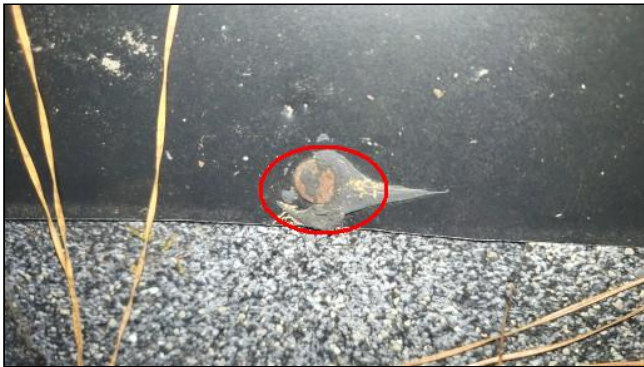
3.1 Item 2(Picture)

(2) The front porch flashing exposed fastener sealant is damaged. Moisture could infiltrate below the flashing causing damage to the adjacent roof structure if this is not addressed. A qualified contractor should evaluate all exposed roofing fastener sealant and perform the necessary repairs.

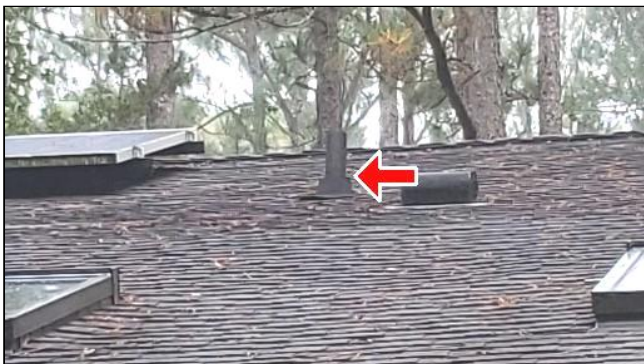
3.2 Item 1(Picture)

The plumbing vent pipe roof flashings appear to be deteriorating where they meet the vent pipes. Some of the pipe flashing flanges are lifted above the shingles at the bottom. Moisture could enter below the pipe flashings causing damage to adjacent building components if it is not addressed. A qualified roofing contractor should examine all roof penetrations and perform the necessary repairs.

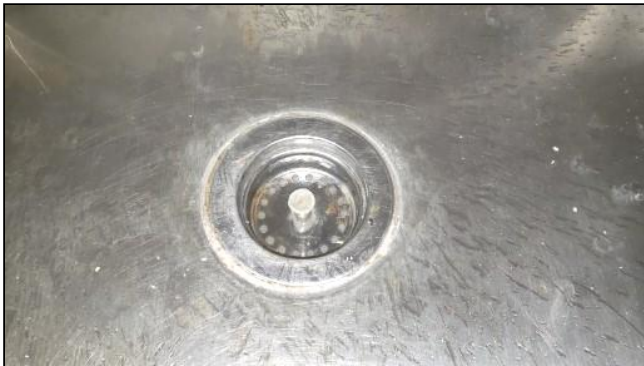
4.1 Item 1(Picture)

(2) The sunroom sink drain stopper does not seal. The basin will not hold water until this has been addressed. A qualified contractor should perform this repair.

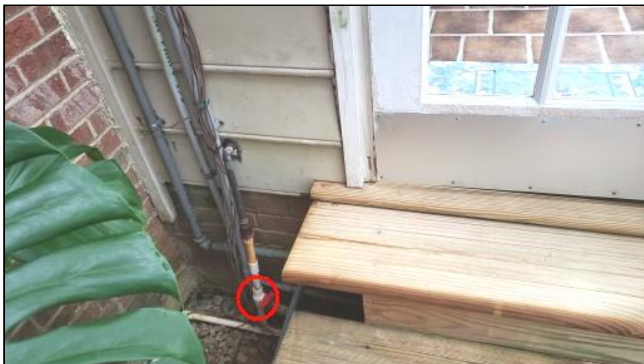
4.2 Item 1(Picture)

A water pipe fitting appears to be leaking adjacent to the steps leading from the greenhouse into the sunroom. Damage could occur to adjacent building components over time if this is not addressed. A licensed plumbing contractor should perform this repair.

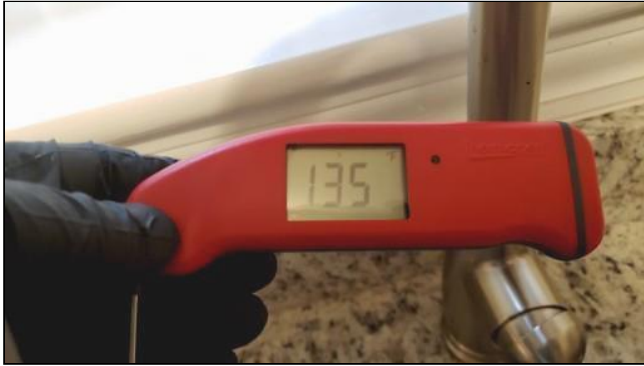
4.3 Item 1(Picture)

(1) The hot water temperature is above 120° F. This is a scald hazard until it is addressed. A licensed plumbing contractor should adjust the temperature so that it does not exceed 120° F at any fixture that provides hot water.

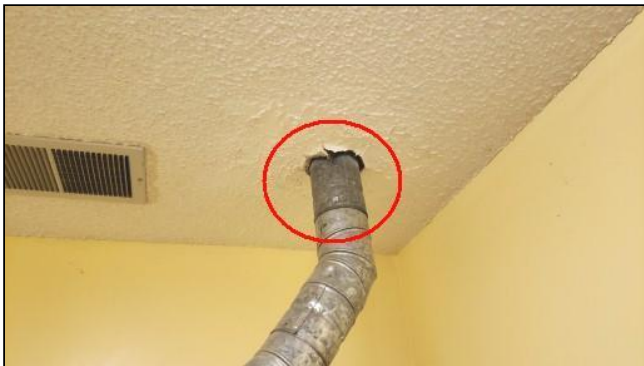
4.3 Item 2(Picture)

(2) The water heater flue is not attached to the draft hood, the flue is not double walled, and is in contact with combustible building materials where it penetrates through the ceiling. All of the above are safety and personal injury hazards until they have been addressed. A licensed plumbing or licensed mechanical contractor should evaluate further and perform all necessary repairs.

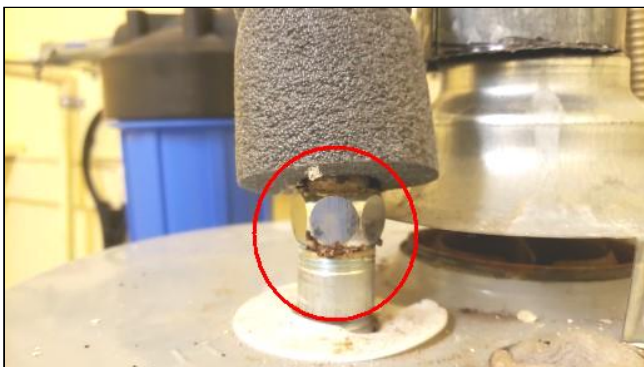
4.3 Item 4(Picture)

(3) Corrosion was noted on the plumbing water pipe fittings on the top of the water heater. Damaging leaks could occur if they are not addressed. A licensed plumbing contractor should evaluate further and perform all necessary repairs.

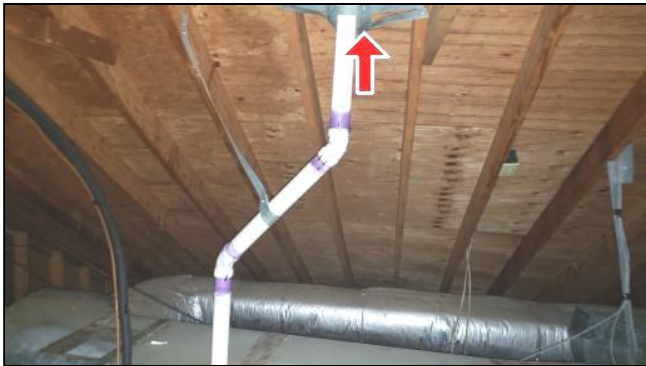
4.3 Item 6(Picture)

(4) A pipe flashing is installed on the bottom of the roof sheathing on the attic furnace flue pipe. If the pipe flashing on top of the roof is damaged and leaking moisture will become entrapped because of damage to the roof sheathing surrounding the vent pipe. A qualified roofing contractor should evaluate further and perform all necessary repairs.

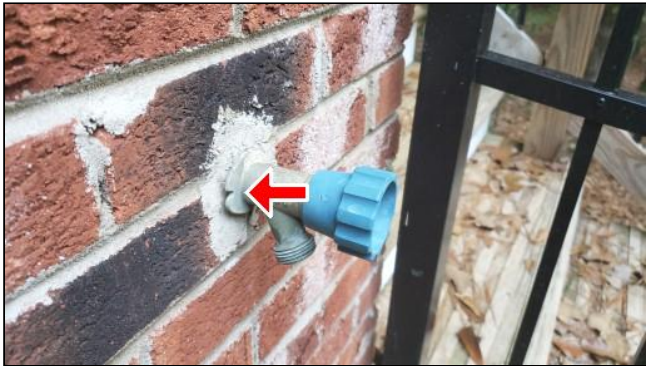
4.4 Item 1(Picture)

(1) The rear hose bib is loose and needs securing to the wall. Damaging leaks could occur in the plumbing water piping and fittings behind the hose bib if this is not addressed. A licensed plumbing contractor should evaluate further and perform all necessary repairs.

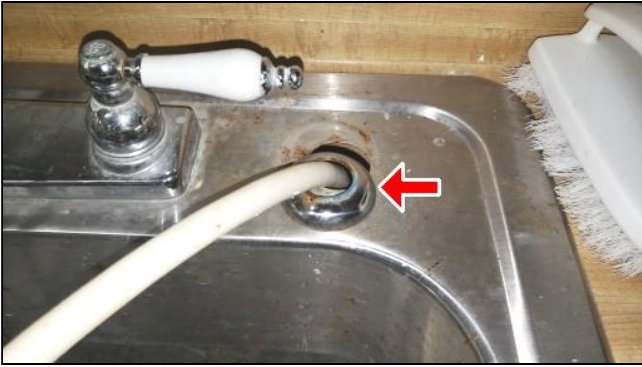
4.4 Item 2(Picture)

- 🏠 (2) The sunroom sink sprayer escutcheon is not securely attached to the sink. Damage could occur to the flexible sprayer hose if this is not addressed. A licensed plumbing contractor should perform this repair.

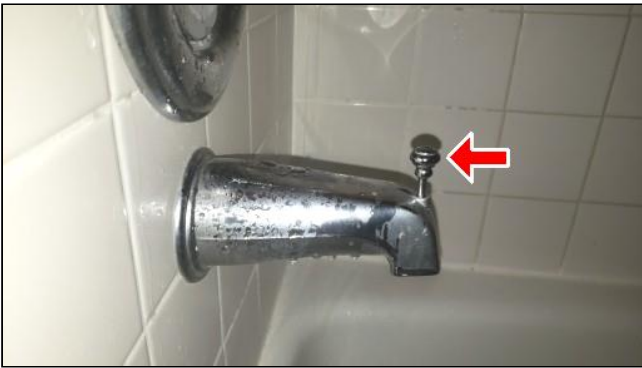
4.4 Item 3(Picture)

- 🏠 (3) The upper level hall bath tub diverter valve not reset to the tub mode when the flow of water is turned off to the showerhead. This is a potential scald hazard until it has been addressed. A licensed plumbing contractor should perform this repair.

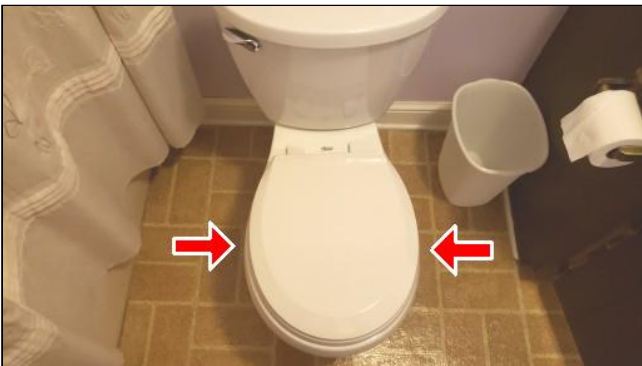
4.5 Item 1(Picture)

- 🏠 (1) The lower level bath toilet is loose at the floor. Damaging leaks could occur if this is not addressed. A licensed plumbing contractor should evaluate further and perform all necessary repairs.

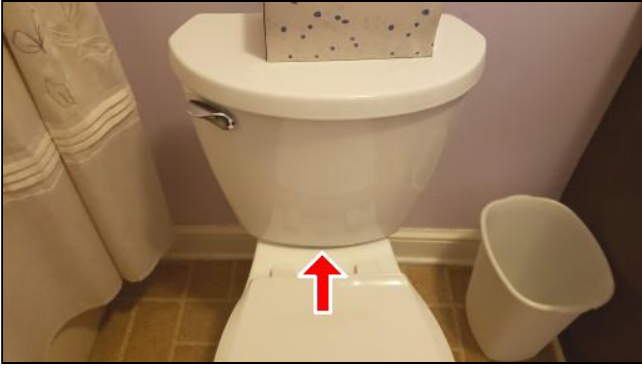
4.5 Item 2(Picture)

(2) The lower level, master bath, and hall bath toilet tanks are loose where they attach to the bowl. Damaging leaks could occur if they are not addressed. A licensed plumbing contractor should evaluate further and perform all necessary repairs.

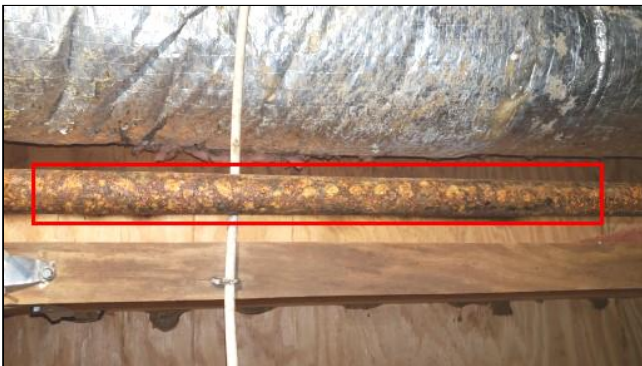
4.10 Item 1(Picture)

(1) Areas of the gas pipe system are corroded. Leaks could develop over time creating safety hazards if they are not addressed. A licensed plumbing or licensed mechanical contractor should evaluate the gas pipe system further and perform all necessary repairs.

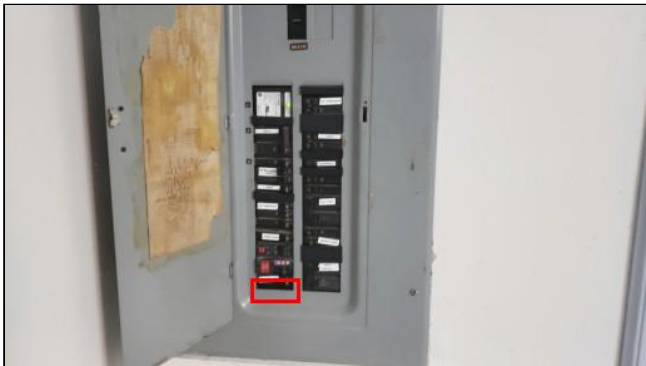
5.0 Item 1(Picture)

- Inspected, Repair or Replace
- (1) A space is present between the main electrical cover and the bottom left disconnect. Electrical shock could occur if this is not addressed. A licensed electrical contractor should perform this repair.

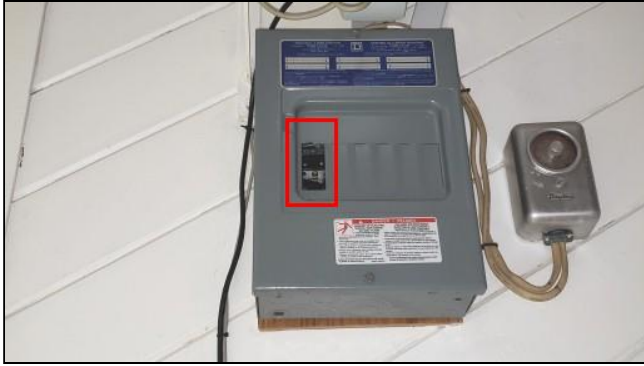
5.0 Item 3(Picture)

(2) An open electrical disconnect space is present in the sunroom electrical panel adjacent to the door leading to the greenhouse. Electrical shock could occur if this is not addressed. A licensed electrical contractor should perform this repair.

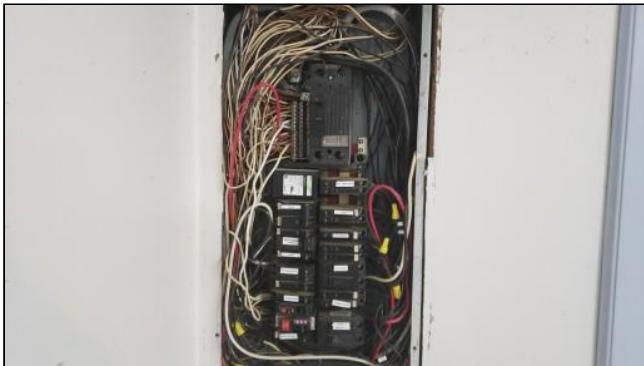
5.0 Item 5(Picture)

(3) There appears to be more wires in the main electrical panel than its capacity allows. Based on the number of electrical issues noted and the lack of professional appearing workmanship in portions of the electrical system, it is recommended that a licensed electrical contractor evaluate the panel as well as the entire electrical system of the home to ensure that all electrical components are functioning as intended and there are no electrical safety hazards.

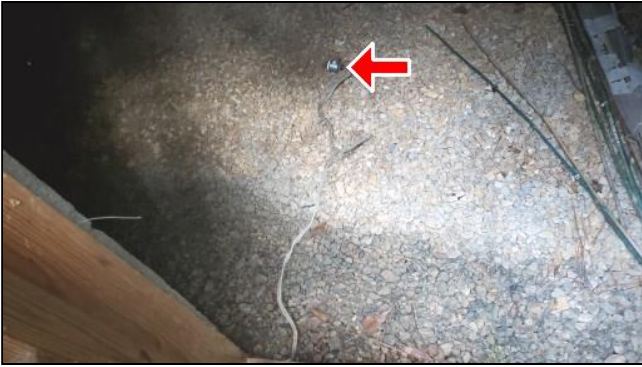
5.3 Item 1(Picture)

- 🏠 (1) A home-made electrical cord is present on the crawlspace floor below the rear sunroom. This is an electrical hazard until it has been addressed. A licensed electrical contractor should perform this repair.

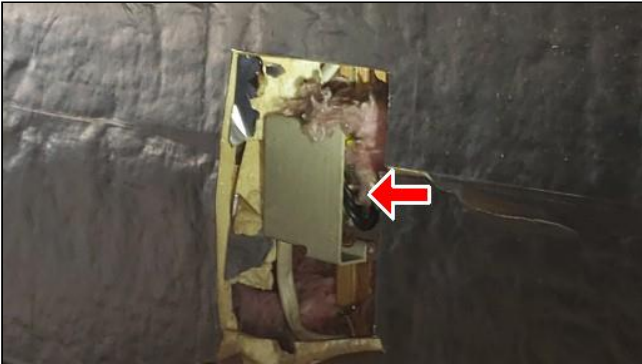
5.3 Item 2(Picture)

- 🏠 (2) The lights over the lower level tub and vanity and over the master tub did not energize from an electrical wall switch. The fixtures are not functioning as intended and need maintenance or repair. Replace the light bulbs. If the fixtures do not illuminate after replacing the light bulbs a licensed electrical contractor should evaluate further and perform all necessary repairs.
- 🏠 (3) Improperly terminated electrical junctions are present in the bonus room kneewall storage areas, upper attic, and crawlspace. These are electrical hazards until they have been addressed. A licensed electrical contractor should perform these repairs.

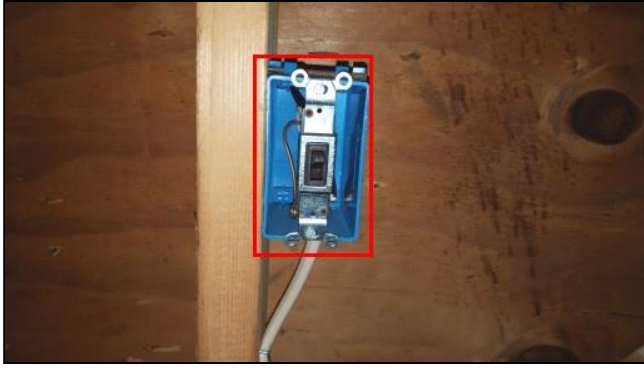
5.3 Item 6(Picture)

- 🏠 (4) Several electrical devices without protective cover plates were noted throughout the home. They are potential electrical shock hazards until the plates have been installed. A qualified contractor should perform these repairs.

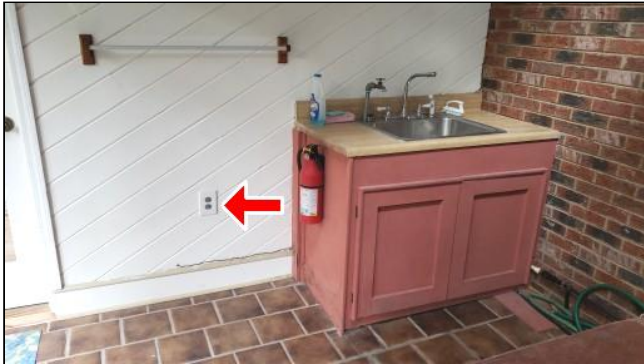
5.7 Item 1(Picture)

(2) The sunroom electrical receptacle adjacent to the sink is not GFCI protected. This is a potential electrical shock hazard until it is been addressed. A licensed electrical contractor should perform this repair.
