Inspection Report

Property Address:
103 Downing Place
Apex NC 27502

Delta Residential, LLC

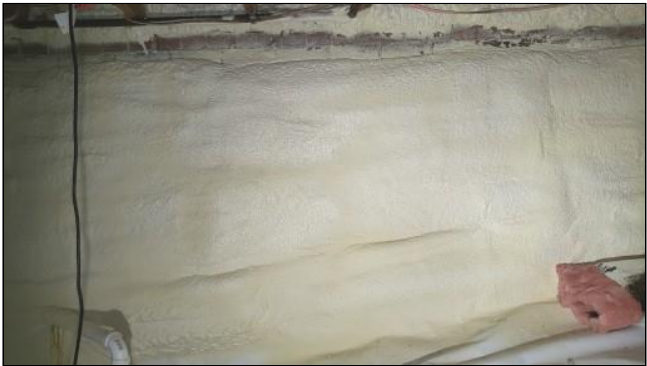
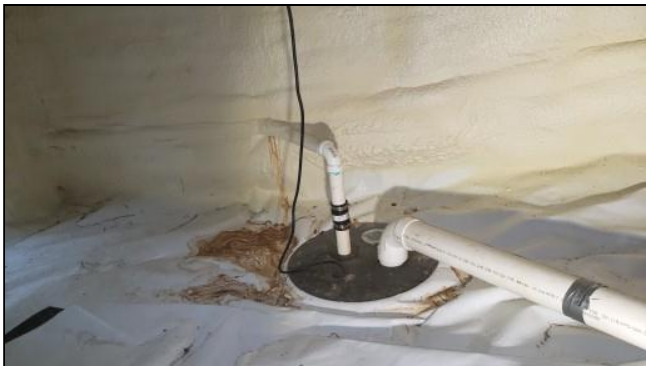
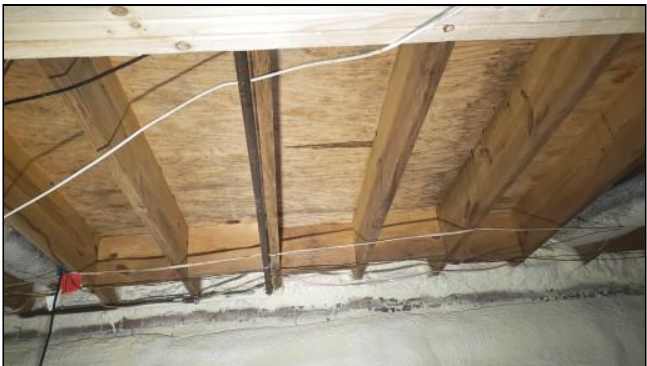
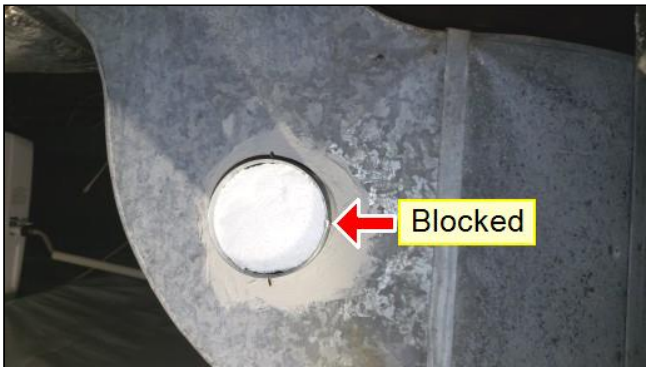
(1) The crawlspace has been sealed but I did not locate a conditioned air supply vent from the HVAC heating and cooling system. It is recommended that the seller provide all documentation and warranties concerning the sealed crawlspace. Retain all documents for future reference.

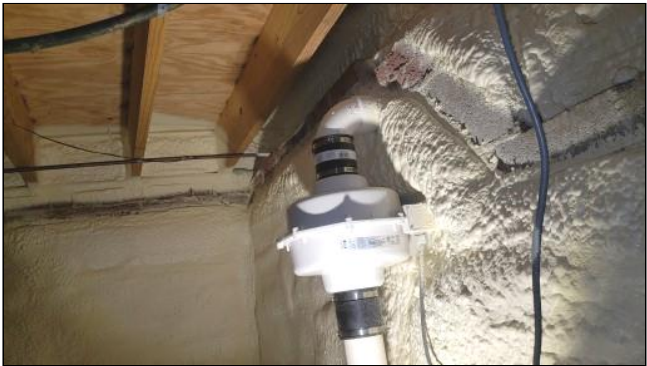
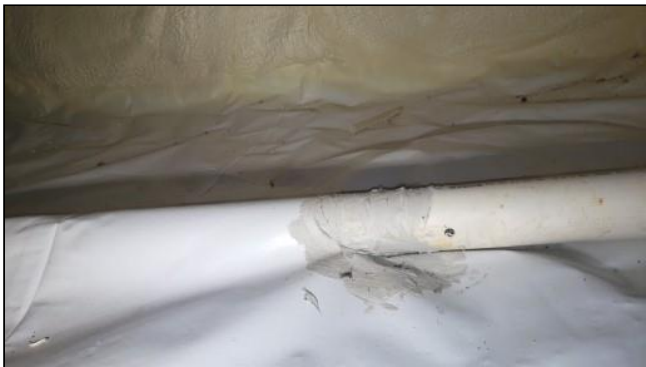
(2) A radon mitigation system is installed in the crawlspace. Testing the system is beyond the scope of a professional home inspection. It is recommended that the seller provide all documentation, radon test results(if any), and warranties concerning this system.

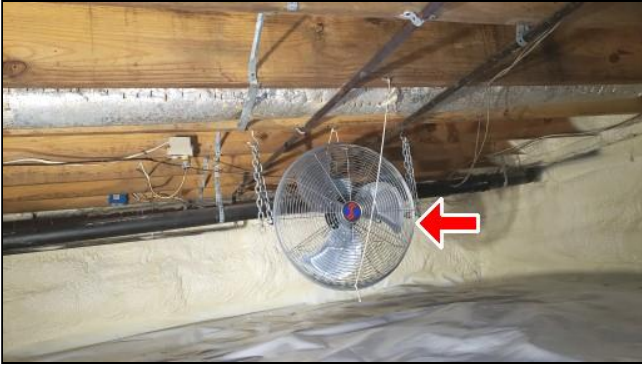
1.0 Item 9(Picture)

(3) An air circulation fan is installed on the bottom of the first level for structure in the crawlspace. This fan was not tested as part of the home inspection. Request the seller to provide all documentation on the fan, its purpose, and warranty information from the installing contractor.

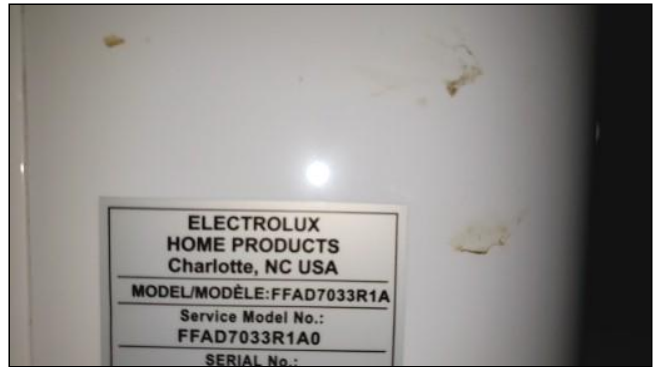
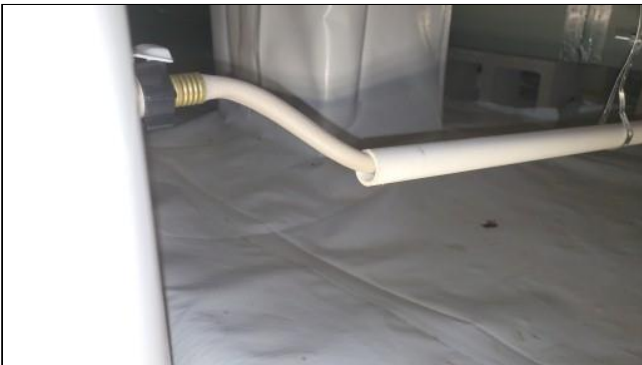
(4) A household-type dehumidifier has been installed in the crawlspace. This type of appliance is not typically rated for use in crawlspaces and is a potential safety hazard. A licensed general contractor experienced in crawlspace atmospheres should evaluate further and perform all necessary repairs, if any are required.

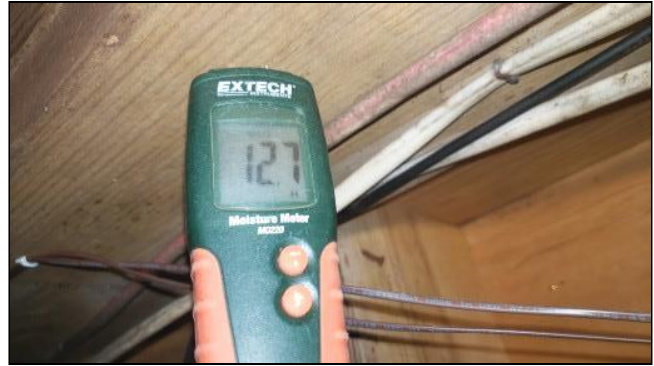
1.0 Item 14(Picture)

(5) Random moisture readings of the wood floor structure components contained in the crawlspace were performed. The highest reading was slightly below 17%. Sustained moisture levels of 18% and higher could create an environment that attracts wood destroying insects and an atmosphere that is conducive to fungal growth. There were no visible signs of damage from high sustained high moisture levels. This comment is for information purposes only.

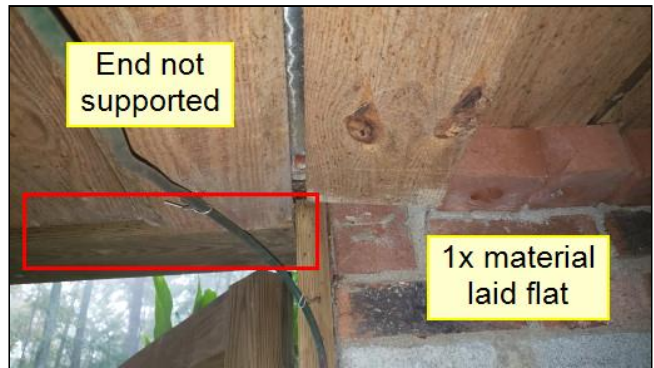
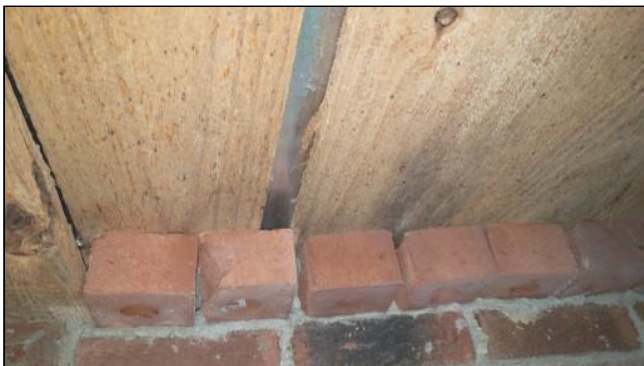
(1) Several of the dropped girder plies in the sunroom crawlspace are not supported by masonry piers. Rough-sawn boards appear to be supporting the floor structure. I am unable to determine the composition of the floor structure above the rough-sawn boards however foil covered insulation board was visible in some of the gaps. The floor structure does not appear to be adequately supported and movement could occur if the above conditions are not addressed. A licensed structural engineer should evaluate to determine if any actions are needed. All recommended repairs should be performed by a licensed general contractor.

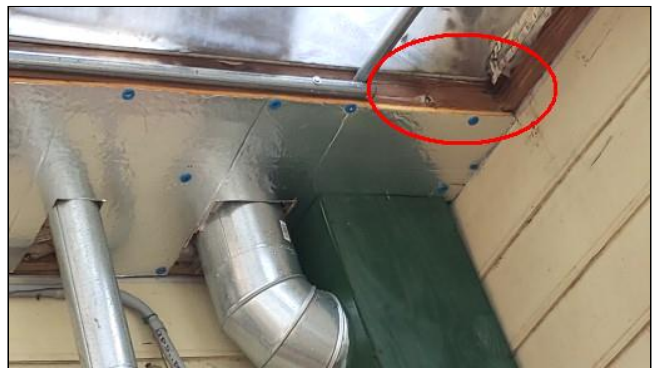
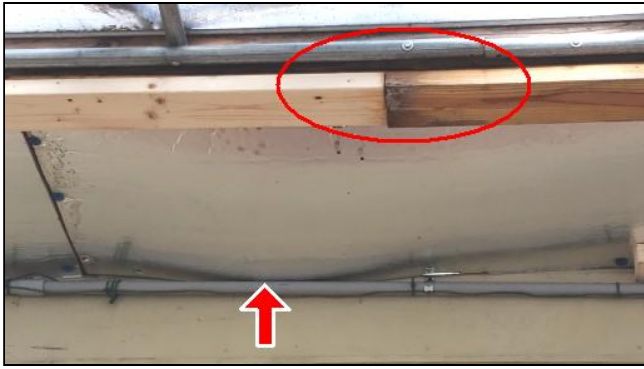
(4) Moisture stains are present on the particleboard in the unfinished room of the bonus room adjacent to the greenhouse. Damage could occur to the adjacent wall and floor structures over time if this is an active leak and it is not addressed. A licensed general contractor should evaluate further to determine if any repairs are needed.

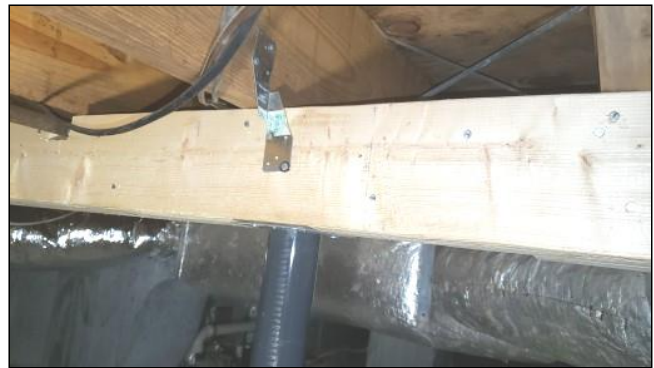
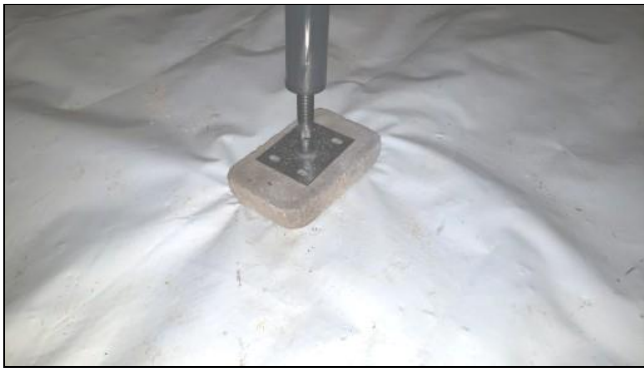
(5) A triple 2 x 6 drop girder supported by adjustable metal peers on an insufficient footing are present in the crawlspace. Movement could occur in this support structure if repairs are not performed. A licensed structural engineer should evaluate to determine if any additional actions are needed. All required repairs should be performed by a licensed general contractor.

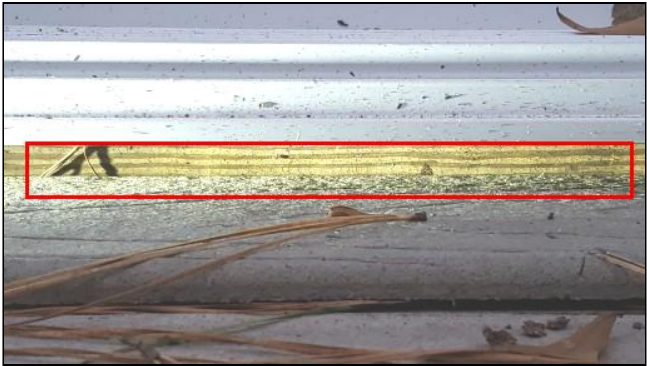
2.1 Item 2(Picture)

(1) The left side sliding glass door sill is not supported or sealed where it meets the deck. Damage could occur to the door and moisture could infiltrate below the door if this is not addressed. A qualified contractor should perform this repair.

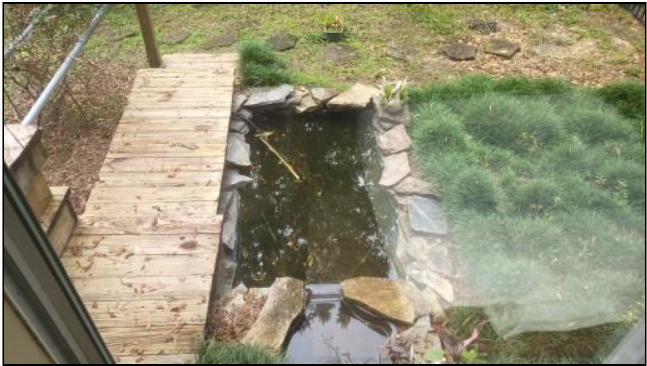
2.1 Item 6(Picture)

(4) The sunroom rear wall sliding glass doors open fully without any type of guardrail. The doors are potential personal injury hazards until they have been addressed. A qualified contractor should evaluate further and perform all necessary repairs.

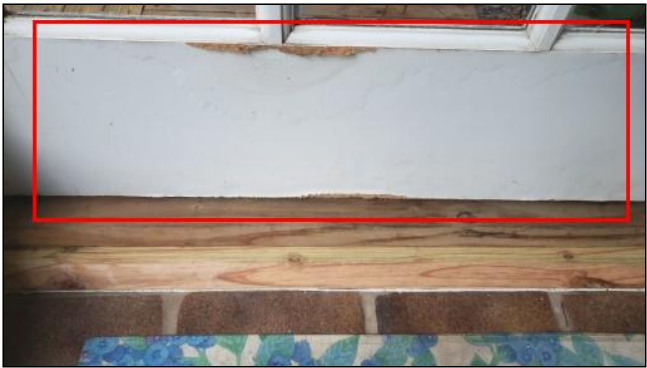
2.1 Item 8(Picture)

(5) The door from the sunroom to the greenhouse is moisture damaged. Additional damage will occur if this is not addressed. A qualified contractor should perform this repair.

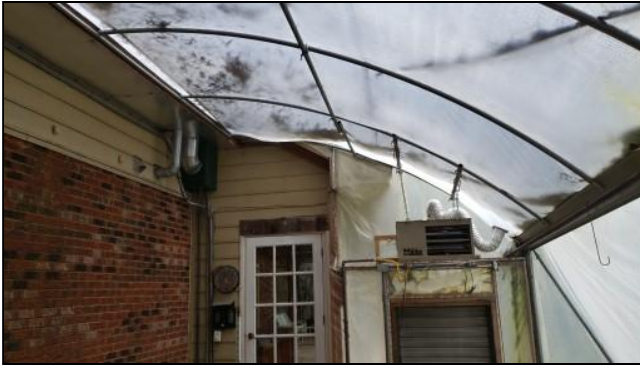
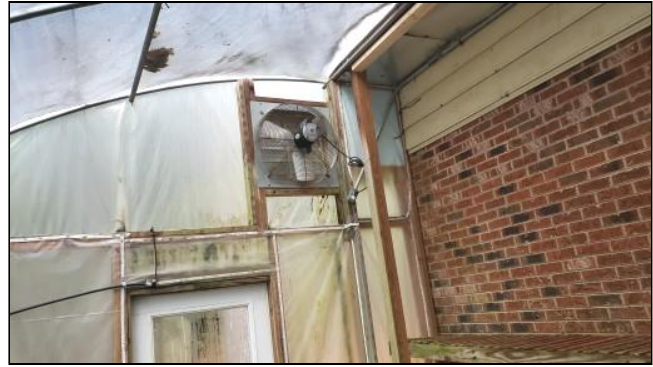
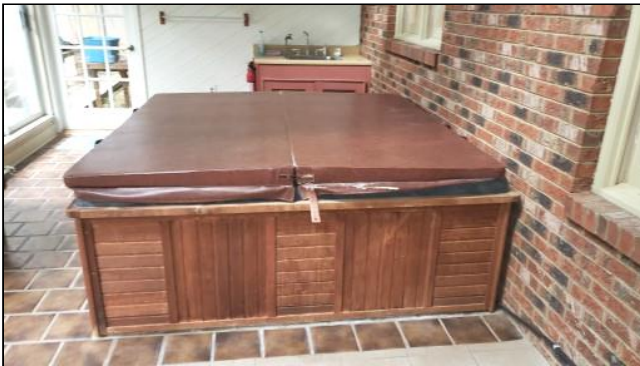
Inspecting or reporting on detached buildings, fences, greenhouse systems, low voltage lighting, and hot tubs are not part of a professional home inspection. No representation is made in this report as to the condition or function of any of the above features on this property. This comment is for information purposes only.

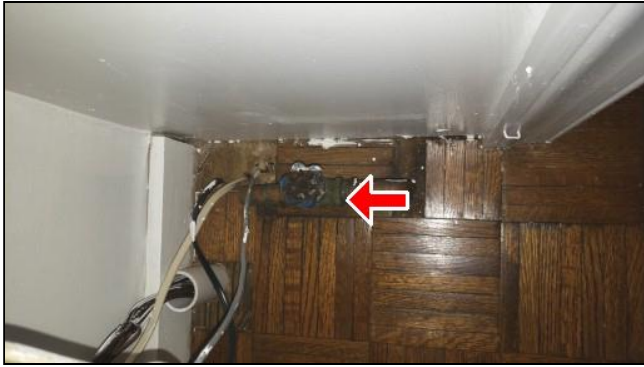
4.0 Item 1(Picture)

The main water shut off is located in the foyer coat closet. This valve controls the flow of water to the entire home. This comment is for information purposes only.

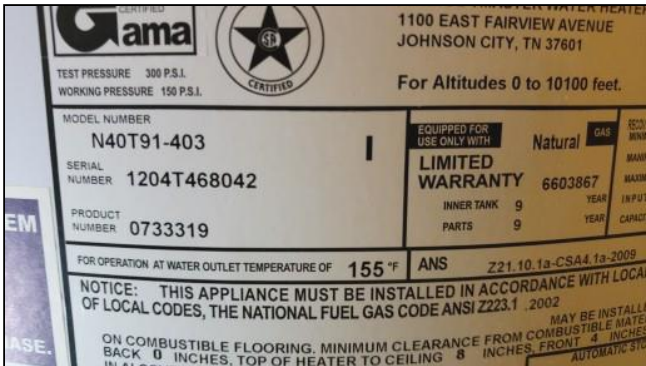
4.3 Item 8(Picture)

(5) This is the water heater manufacturer's identification label. Copy and paste the link below to Building Intelligence Center in your web browser in order to determine its date of manufacture from the Serial number. This comment is for information purposes only.

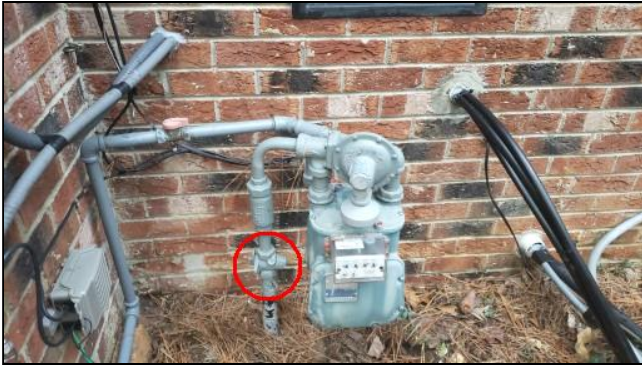
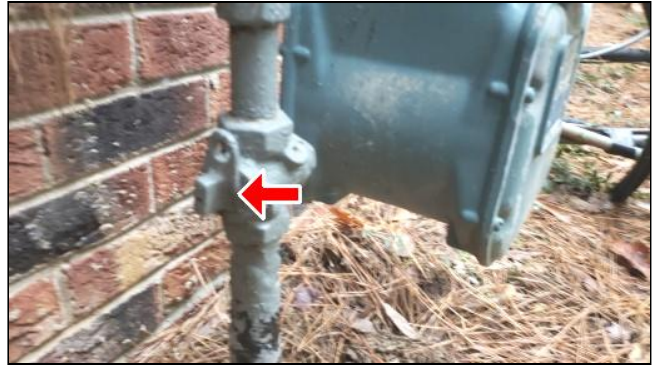
(1) Areas of the gas pipe system are corroded. Leaks could develop over time creating safety hazards if they are not addressed. A licensed plumbing or licensed mechanical contractor should evaluate the gas pipe system further and perform all necessary repairs.

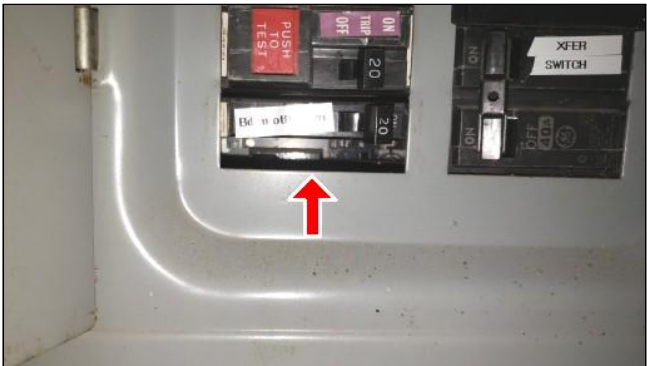
5.0 Item 2(Picture)

- Inspected, Repair or Replace
- (1) A space is present between the main electrical cover and the bottom left disconnect. Electrical shock could occur if this is not addressed. A licensed electrical contractor should perform this repair.

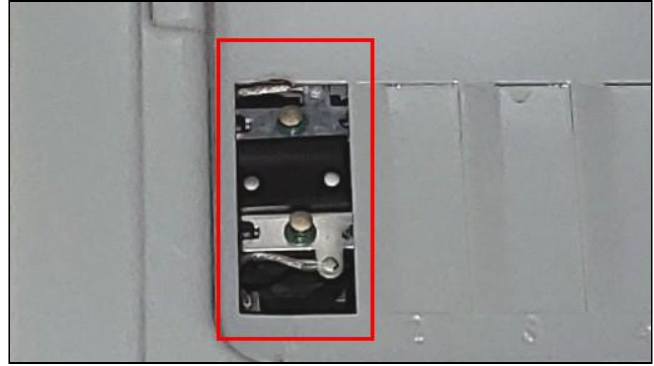
5.0 Item 4(Picture)

(2) An open electrical disconnect space is present in the sunroom electrical panel adjacent to the door leading to the greenhouse. Electrical shock could occur if this is not addressed. A licensed electrical contractor should perform this repair.

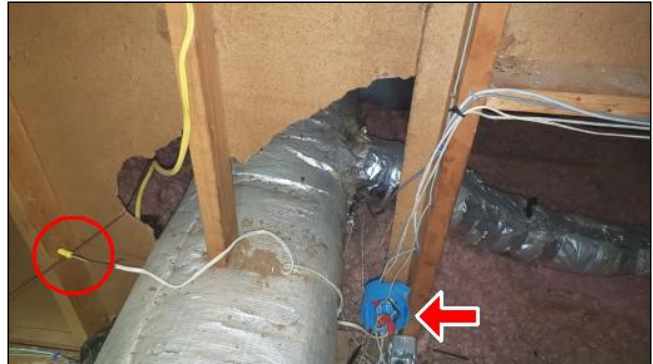
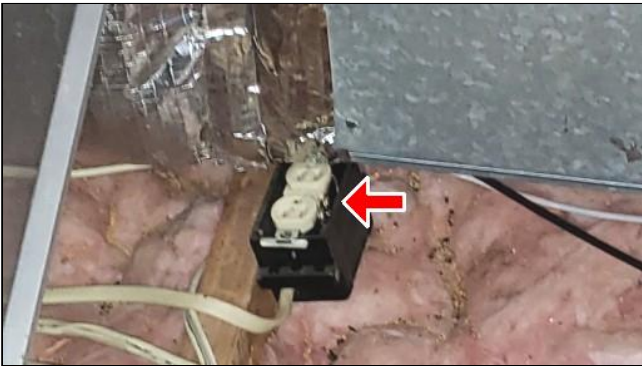
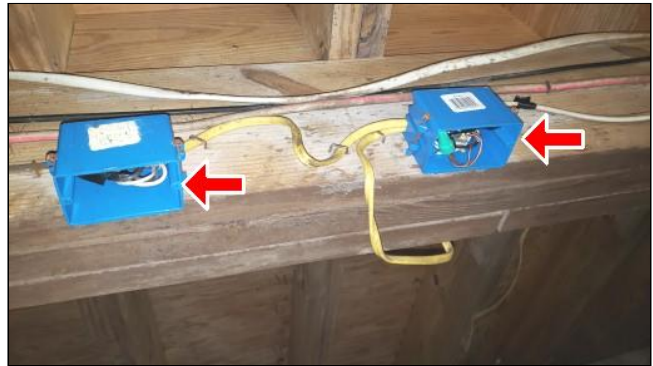
- 🏠 (2) The lights over the lower level tub and vanity and over the master tub did not energize from an electrical wall switch. The fixtures are not functioning as intended and need maintenance or repair. Replace the light bulbs. If the fixtures do not illuminate after replacing the light bulbs a licensed electrical contractor should evaluate further and perform all necessary repairs.
- 🏠 (3) Improperly terminated electrical junctions are present in the bonus room kneewall storage areas, upper attic, and crawlspace. These are electrical hazards until they have been addressed. A licensed electrical contractor should perform these repairs.

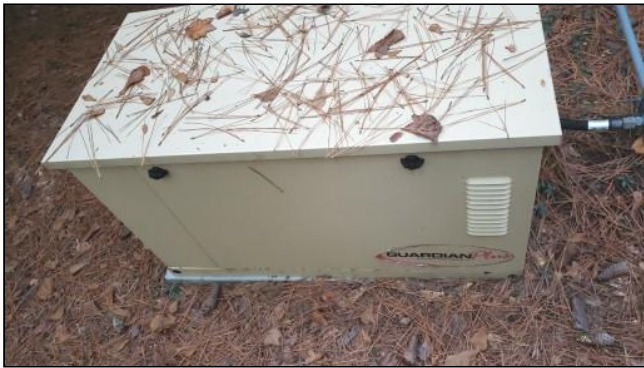
5.3 Item 7(Picture)

(5) The home has an auxiliary generation system and solar collectors on the roof which are believed to be for heated water. Operating and inspecting these systems are beyond the scope of a professional home inspection. No representation is made or inferred in this inspection report as to the function or condition of any of the above systems or their individual components. This comment is for information purposes only.

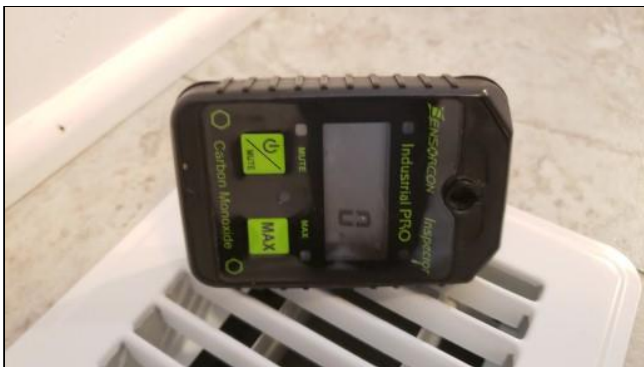
6.0 Item 3(Picture) Lower level

(2) A professional grade carbon monoxide testing device was utilized while the lower level gas HVAC heat system was operating. No carbon monoxide was detected. This comment is for information purposes only.

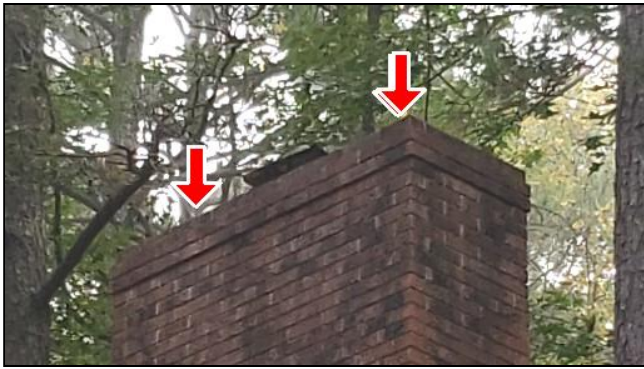
6.5 Item 1(Picture)

(1) Most masonry fireplaces have a mortar cement finish on the top exterior of the chimney. These mortar finishes tend to crack as they age which could allow moisture infiltration into the chimney

structure. It is recommended that a certified chimney sweep evaluate the top of the fireplace chimney mortar finish and perform all necessary repairs if any are required.

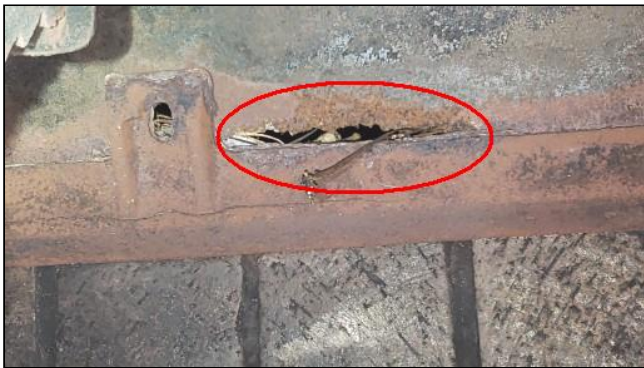
6.5 Item 2(Picture)

(2) Fireplace damper door is damaged. The damper will not function as intended until it has been addressed. A qualified chimney sweep should perform this repair.

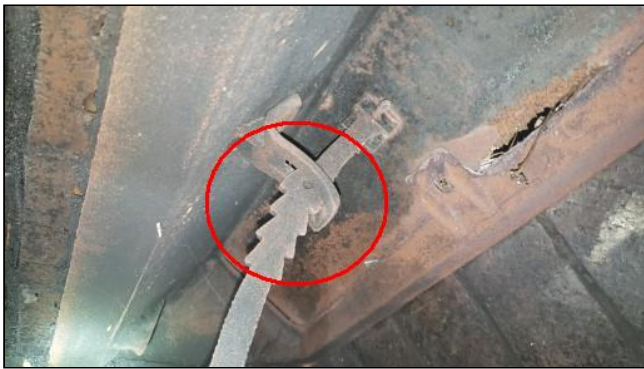
6.6 Item 1(Picture)

(1) The F/P has gas logs. The damper located at the top of the firebox does not have a mechanism that will lock the damper door in the open only position. This is a safety hazard. A certified gas F/P technician should install the device.

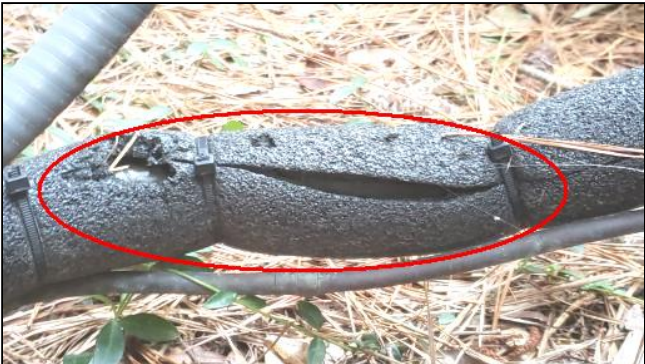
7.0 Item 1(Picture)

(2) Refrigerant line insulation is damaged adjacent to the HVAC condensing unit. The operating efficiency of the system could be diminished if this is not addressed. A licensed mechanical contractor should perform this repair.

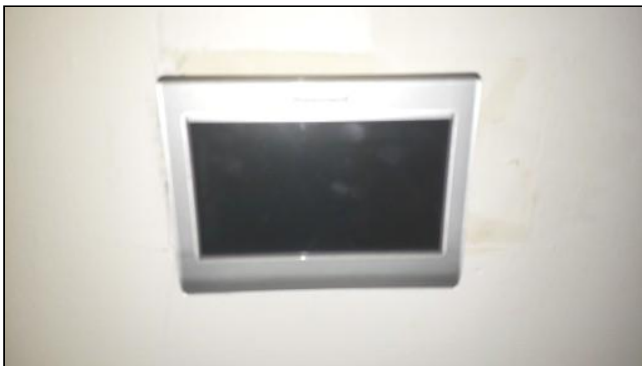
7.1 Item 1(Picture)

The upper level thermostat screen was non-responsive out at the time of the inspection. The upper level HVAC heating and cooling system did not function. A licensed mechanical contractor should evaluate further and perform all necessary repairs.

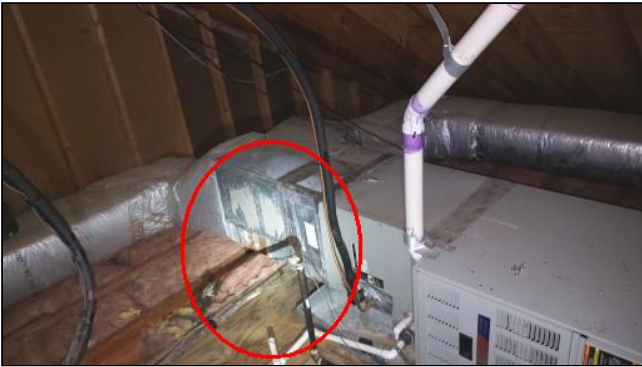
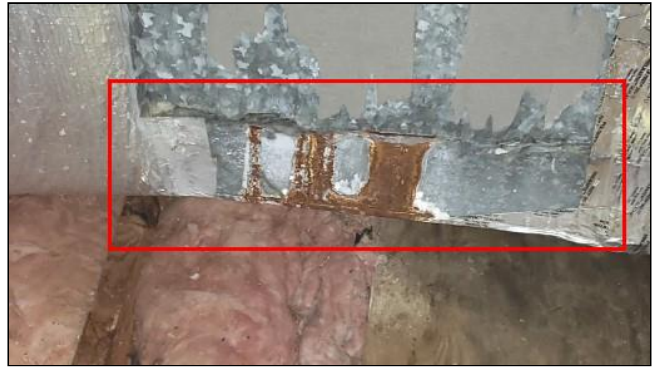
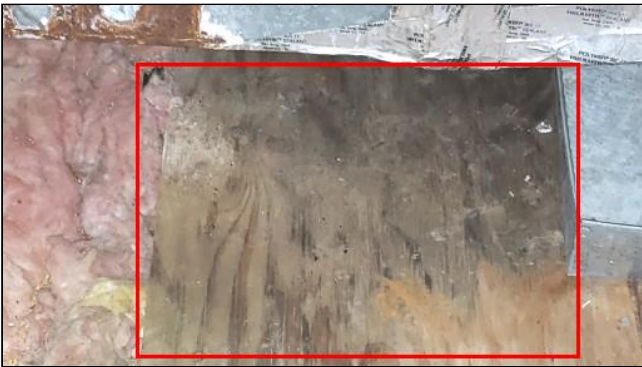
The HVAC metal duct in the attic is corroded and moisture stains are present on the attic flooring below. The duct system not functioning as intended and needs maintenance or repair. A licensed mechanical contractor should evaluate further and perform all necessary repairs.

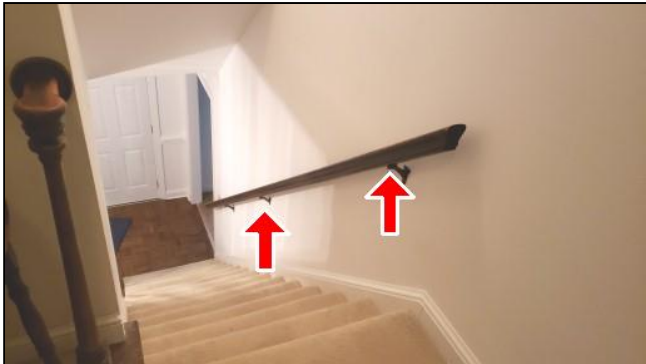
8.0 Item 1(Picture)

(1) The main stair rail is loose where it attaches to the wall. A fall or injury could occur should it give way under weight. A qualified contractor should evaluate further and perform all necessary repairs.

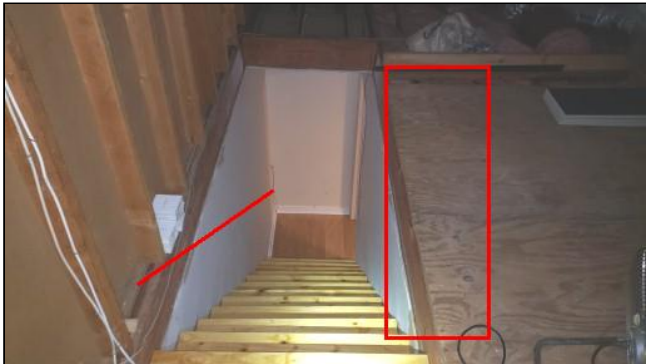
8.0 Item 2(Picture)

(2) A guardrail is not present on the attic floor at the stairwell and a wall rail is not present on the attic stairs. Personal injury could occur if they are not addressed. A qualified contractor should perform these repairs.

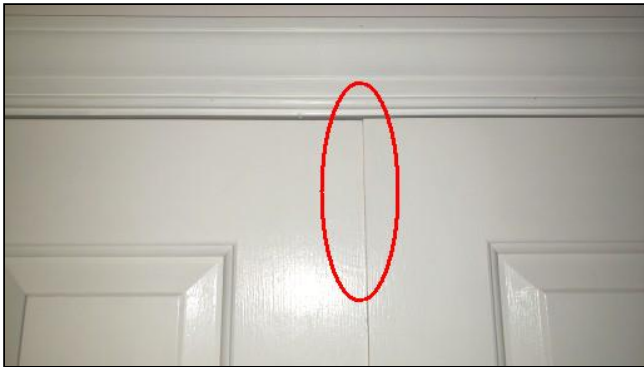
8.5 Item 1(Picture)

(2) The lower level closet doors rub one another at the top. Damage could occur to the doors if they are not addressed. A qualified contractor should perform this repair.

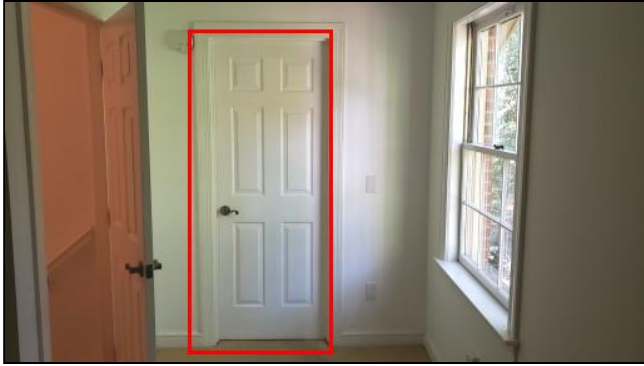
8.5 Item 2(Picture)

- 🏠 (3) The door leading from the bonus room to the unfinished room adjacent to the greenhouse is not weatherstripped or insulated. The energy efficiency of the door will be reduced until these Items have been installed. A qualified contractor should perform these repairs.

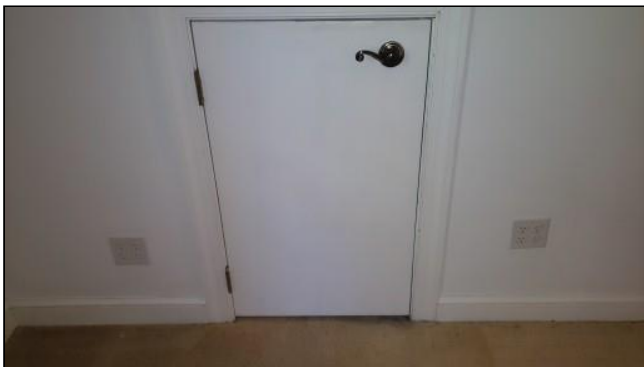
8.5 Item 3(Picture)

- 🏠 (4) The bonus room kneewall storage doors are not insulated. The energy efficiency of the doors will be reduced until they have been addressed. A qualified contractor should perform these repairs.

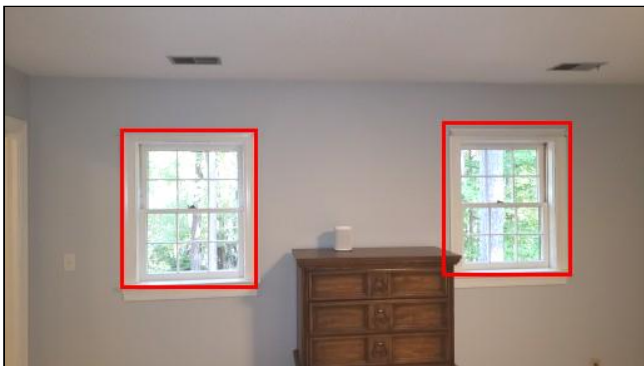
8.6 Item 1(Picture)

- 🏠 (1) Some of the windows are stuck shut. They are potential safety hazards in the event that emergency egress is needed. A qualified contractor should perform these repairs.
- 🏠 (2) The master bedroom windows do not meet today's emergency egress requirements. this was allowed at the time of original construction but is considered a safety hazard by today's standards. A licensed general contractor should evaluate further to discuss options on meeting today standards if you so desire.

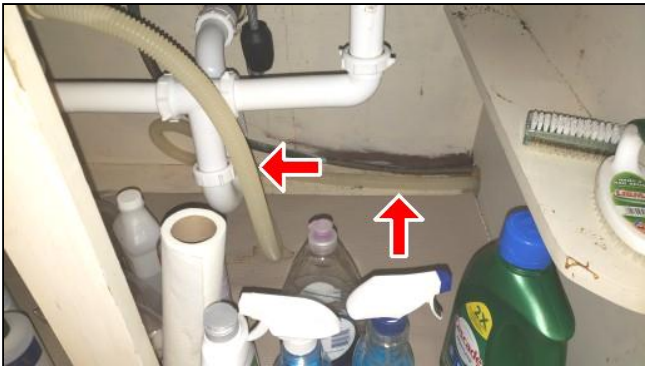
10.0 Item 1(Picture)

- (1) The drain pipe for the dishwasher is not installed so that a portion of the drain pipe is higher than the point where it attaches to the plumbing drain system under the sink. This minimizes the possibility that water from the sink could flow into the dishwasher. A licensed plumbing contractor should perform this repair.
